CASE REPORT

Nagoya J. Med. Sci. **82**. 799–805, 2020 doi:10.18999/nagjms.82.4.799

An intraoperative 3D image-based navigation error during cervical pedicle screw insertion

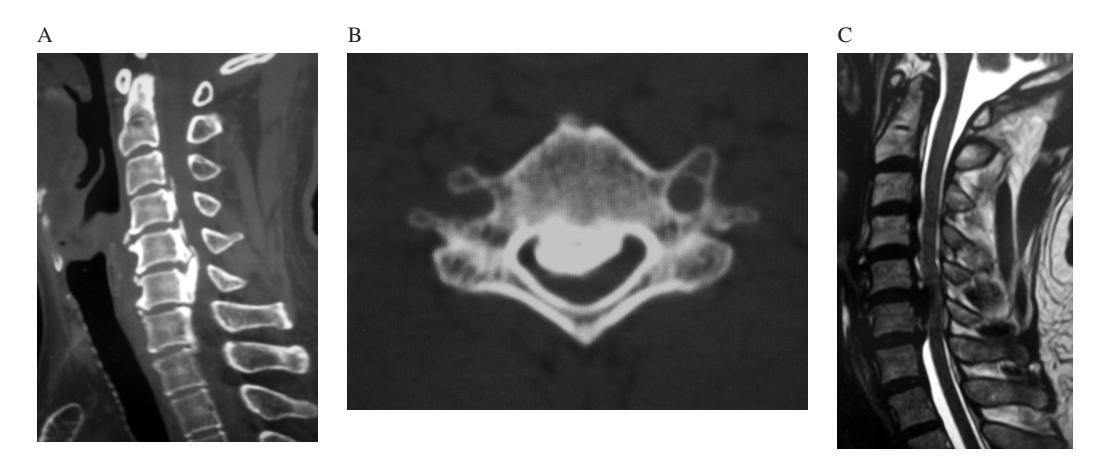
Fig. 1 Preoperative images

(A, B) Ossification of the posterior longitudinal ligament (OPLL) at C3-6. Computed tomography axial image at C6 showing a large ossification in the cervical spinal canal. (C) Compression of the spinal cord due to OPLL.

An X-ray examination of the cervical spine and computed tomography (CT) showed OPLL at C3-6. Magnetic resonance imaging (MRI) showed canal stenosis and compression of the spinal cord due to OPLL (Fig. 1A-C). Thus, the patient was diagnosed with myelopathy due to cervical OPLL, and posterior cervical decompression surgery with fixation was performed. Preoperative CT angiography of the cervical spine revealed VA laterality, with the left-side VA being larger than the right-side VA. Therefore, we chose CPSs for the right and lateral mass screws for the left side as the fixation implants.

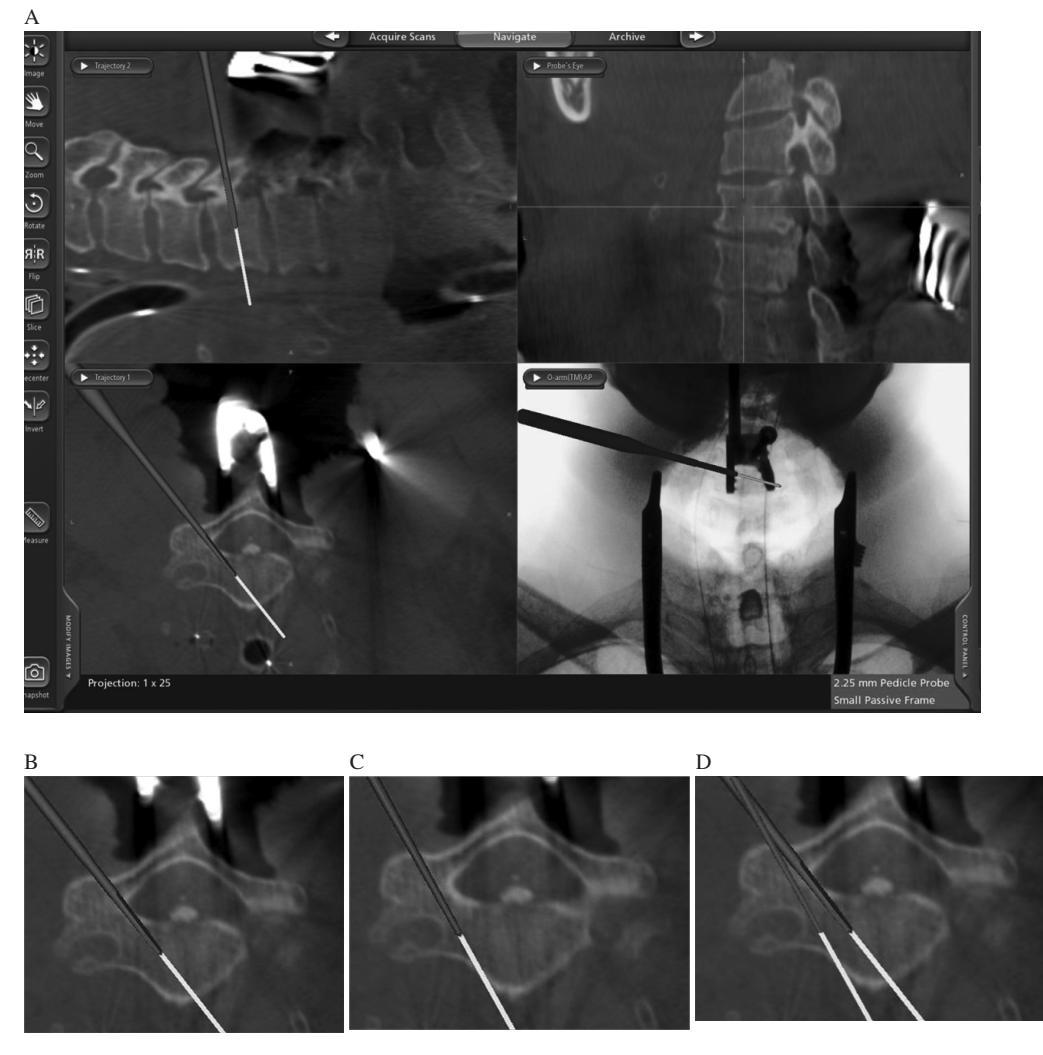
Fig. 2 Navigation screens during surgery

(A) Intraoperative navigation screen showing the 3D trajectory constructed by intraoperative O-arm 3D images. (B, C) Magnified intraoperative navigation screens in the axial view, showing trajectories of the probe with and without probing force, respectively. The trajectory in (B) is more medial than that in (C). (D) The 10-degree discrepancy between the trajectories in (B) and (C).

Intraoperative navigation screens are shown in Fig. 2. Images taken during probing and making of the screw hole by the navigation probe with and without a probing force are shown in Figs. 2B and 2C, respectively. A comparison of these images indicates that the navigation trajectory was more medial with a probing force (a better trajectory to ensure safety of the foramen transversarium and VA), with a difference of about 10° (Fig. 2D). The same phenomenon was also recorded during C6 CPS insertion.

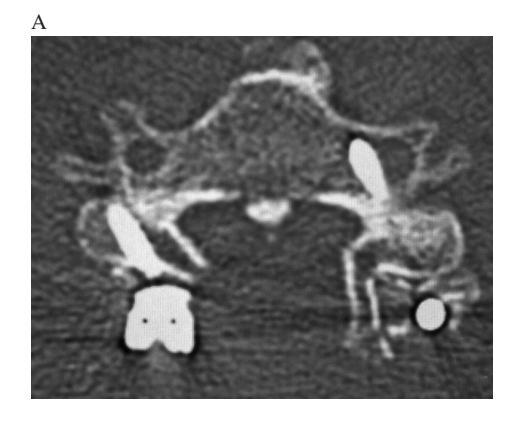
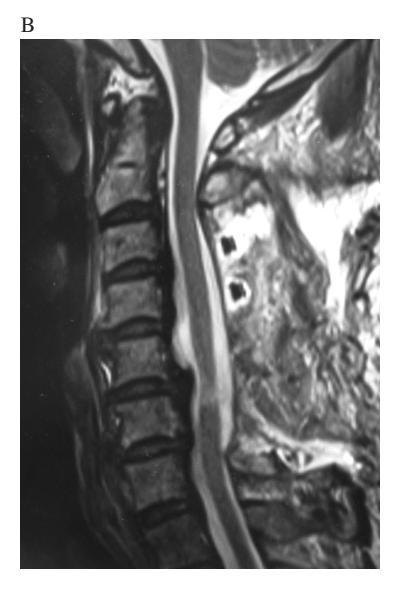
Fig. 3 Postoperative images

(A) Left-side cervical pedicle screws (CPSs) displayed small lateral perforations of <2 mm (i.e., less than half of the screw diameter) to the foramen transversarium at C5. (B) Decompression of the spinal cord, showing expansion of the dura mater.

The accuracy of all screw placements (CPSs and lateral mass screws) was evaluated by postoperative CT. The C5 and C6 CPSs showed lateral perforations of <2 mm (i.e., less than half of the screw diameter) to the foramen transversarium (Fig. 3A). The CPS trajectories on postoperative CT were almost the same as the trajectory shown on the intraoperative navigation screen images without a probing force. The lateral mass screws were not perforated.

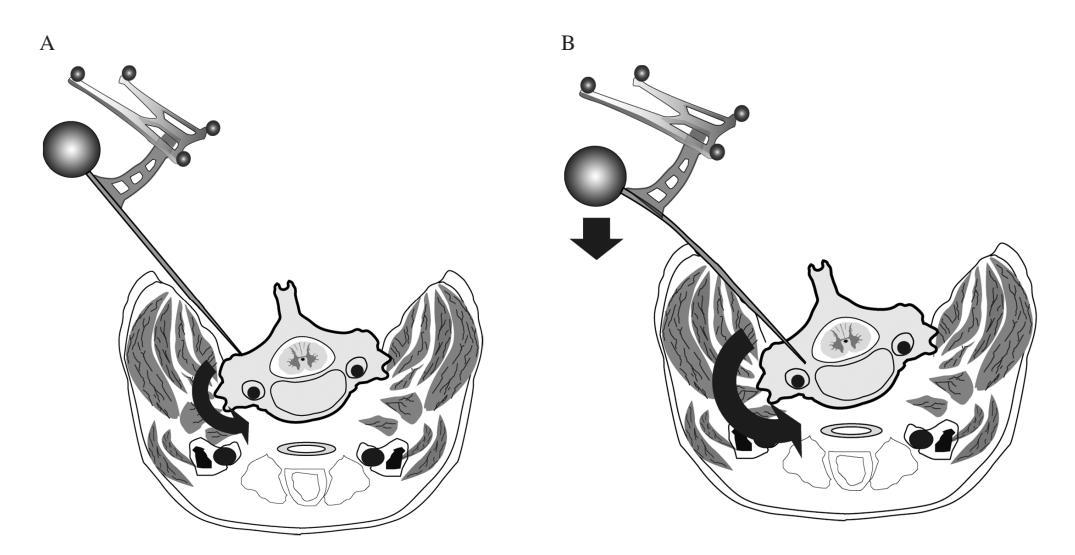
Fig. 4 Mechanism of malposition during cervical pedicle screw insertion

(A) During creation of the screw hole by the navigation probe, the vertebra is rotated (arrow). (B) The stronger the probing force, the more the vertebra is rotated like a curved arrow, resulting in probe bending (block arrow). As a result, the tip of the probe is directed more laterally, towards the vertebral artery. On the other hand, the handle and antenna of the probe are positioned laterally due to the probe bending; hence, this phenomenon creates the ideal trajectory for the probe on the navigation screen.

In this case, each vertebra (C5 with a reference frame and C6 without a reference frame) showed navigation errors (Fig. 4A, B), suggesting that this phenomenon might not be related to the position of the reference frame or due to intervertebral movement. Instead, the error occurred when force was added to the probe during CPS insertion, leading us to hypothesize the following reasons for this finding: first, force on the probe during creation of the screw hole may have caused vertebra rotation¹⁶ (Fig. 4A). Second, the trajectory of the probe tip may have moved laterally (Fig. 4B). Finally, in correspondence to the rotation, the operator may have added more force and an increased angle to ensure a correct trajectory. As a result, only the navigation antenna of the probe would move to the ideal point for CPS placement, while the tip of the probe would be left in the lateral trajectory, causing a bowed navigation probe (Fig. 4B). Thus, a navigation error may occur even if the vertebra has an attached navigation frame. To reduce navigation errors after experiencing the current case, we changed to create CPS holes using a newly developed power drill tool that can be navigated. This navigated drill makes it possible to create CPS holes by drilling without pressing the cervical spine. Since the bone cortex might be perforated by using this power tool, we use this drill with a very low rotation. The accuracy of CPS placement has become better, and the results will be reported in a near future paper.

In conclusion, based on the present case, we believe that a surgeon inserting CPSs using a navigation system should keep in mind the possibility of probe flexure due to restrictions of the cervical posterior muscle and rotation of vertebrae. To ensure safe and accurate CPS insertion, percutaneous insertion of screws using a navigation system might reduce the risk of CPS malposition by the posterior cervical muscles.^{7,9,12} Nevertheless, navigation error during CPS insertion can occur even with intraoperative 3D image-based navigation. Even for vertebrae with a navigation reference frame, the risk of posterior cervical muscle restrictions and vertebra rotations should not be ignored to ensure safe CPS insertion.
